Fracture Analysis of High-Strength Screw for Highway Construction

Citation: Dubec, A.; Kováčiková, P.; Krmela, J.; Krmelová, V.; Artyukhov, A. Fracture Analysis of High-Strength Screw for Highway Construction. *Materials* **2021**, *14*, 1599. <https://doi.org/10.3390/ma14071599>

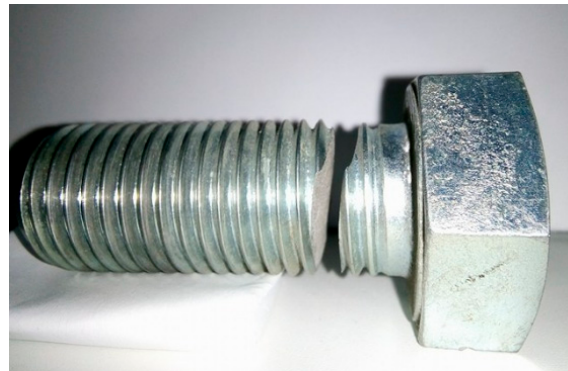
Figure 1. Operational fracture of high-strength screw.

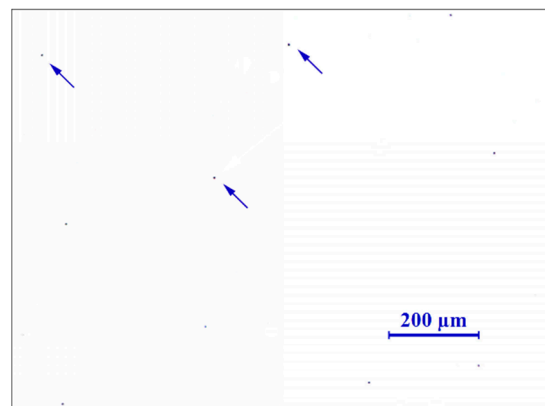
To be able to evaluate the micropurity, the microstructure and the surface treatment of the broken screw, a sample from the longitudinal section was taken from the area close to the fracture surface. The gaining of the given information was connected with the preparation of the samples in a metallographic way. Analysis of micropurity, which was performed by optical microscopy, showed that high-purity steel with local occurrence of subcritical oxides was used for the production of the high-strength screw of 10.9 strength grade. Oxide inclusions (indicated with arrows in Figure 2) were observed at $100\times$ magnification and their size was evaluated as well as assigned to the grade of 1, referring to the standard series based on standard ČSN ISO 4967 (420471). At the mentioned magnification, which is prescribed by the mentioned standard, there was not any occurrence of other types of inclusions [27]. After etching of the polished surface with 2% Nital etchant, the microstructure of the screw was observed and it corresponded to the tempered martensite (Figure 3). This type of microstructure can be achieved in steel by quenching and subsequent tempering and it represents the suitable selection of the heat treatment technology for this type of joining component. In the further part of the experiment, it was necessary to perform a hardness measurement analysis and microstructure morphology analysis by scanning electron microscopy in order to determine the exact type of bainitic structure, which mainly depends on the tempering temperature used. In the central area of the screw, the microstructure was mainly based on the direction of plastic deforming of the semiproduct, which was used for subsequent production of final screw component. On the other side, there was not any significant change of the direction observed in the marginal part. In the polished state, the presence of a surface layer was observed on the surface of the investigated sample. This layer was not uniform and its thickness ranged from 2.7 to 5.5 μm (Figure 4). Including overall mapping analysis, energy dispersive spectroscopy was applied for investigation of the sample and it is important to point out that there was the Zn layer recognized. The defect sites of the surface layer were observed at several areas. In the threaded part, the layer was discontinuous with its complete absence in the individual microlocalities.

Figure 2. Local occurrence of the oxide inclusion.

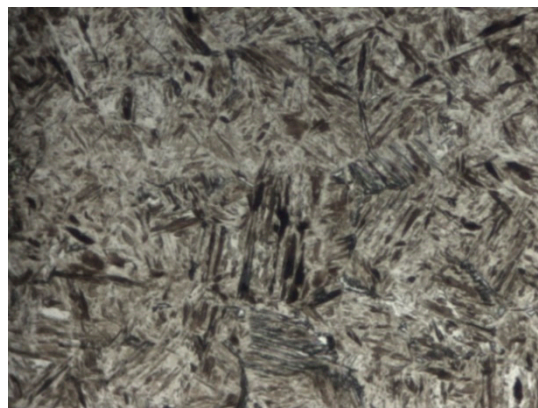
Figure 3. Microstructure of the tempered martensite.

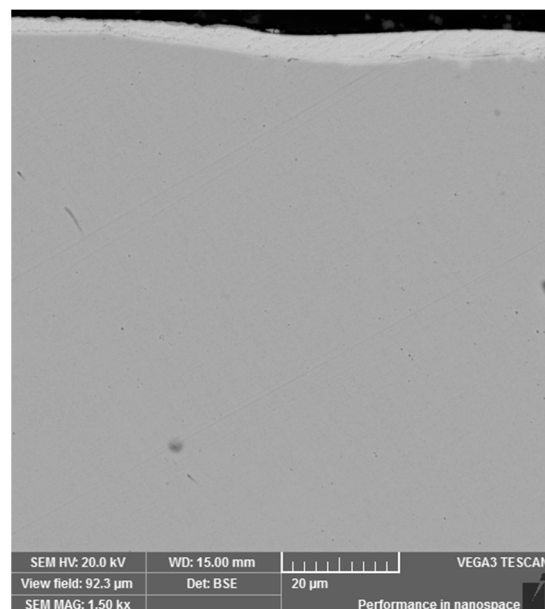
Figure 4. Protective Zn surface layer.

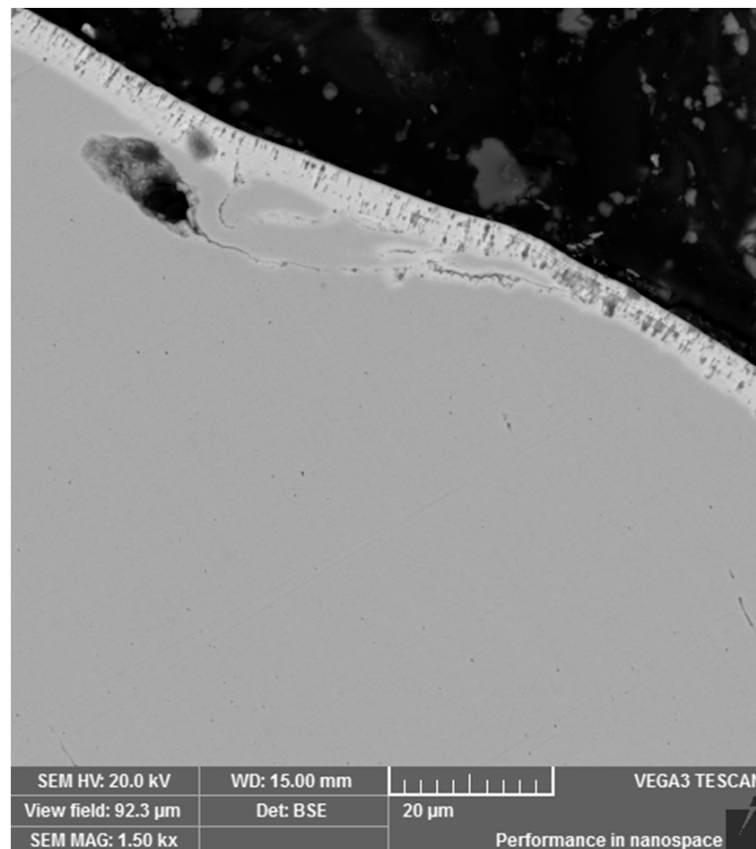
In addition, microcrack propagation through the overall thickness as well as peeling of the surface layer in several areas were determined. The occurrence of folds was observed on the surface of the rolled material and the given areas with laps can be considered as the consequence of the threads production by rolling technology (Figure 5). Moreover,

microcavities could also be observed in these mentioned areas. In relation to the areas with the absence of the Zn layer, there were the visible sites with microcrack initiation and the given microcracks were propagated into the core of the material at an angle value which was close to 45° . If such an angle of the surface microcrack propagation remains, it can significantly increase the risk of weakening in relation to the load-bearing cross-section of the high-strength screw. When the microcrack changes the direction of its propagation towards the surface of the material (Figure 6), the surface of material is peeled off during further microcrack propagation. This process can significantly increase the surface roughness of the thread contact surfaces. In addition, the released material moves freely when the screw is tightened between the threaded areas of the screw and the nut. It is also necessary to point out that there is the change in the surface roughness of the contact surfaces. The surface microcracks were recognized in the area of the thread crest as well as in the area of the thread root. The microspace, which occurred by the propagation of microcracks in the material, was filled with corrosive elements and Zn.

Figure 5. Lap (fold)—area with defect of Zn surface layer.

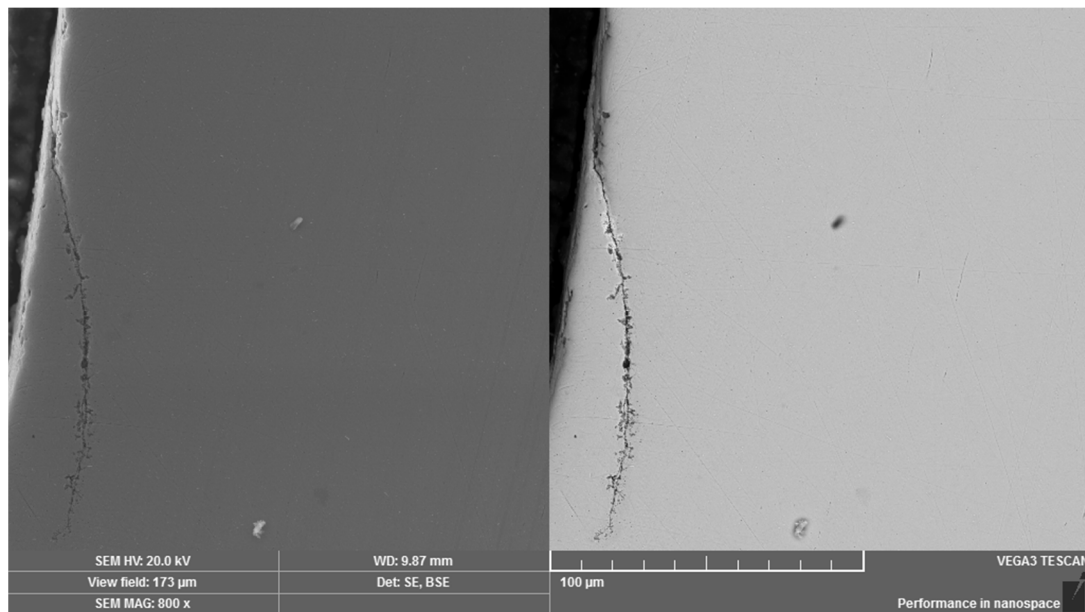
Figure 6. Change in direction of microcrack propagation towards the surface of thread part. Dual representation of the analyzed area: (left) SE mode, (right) BSE mode.

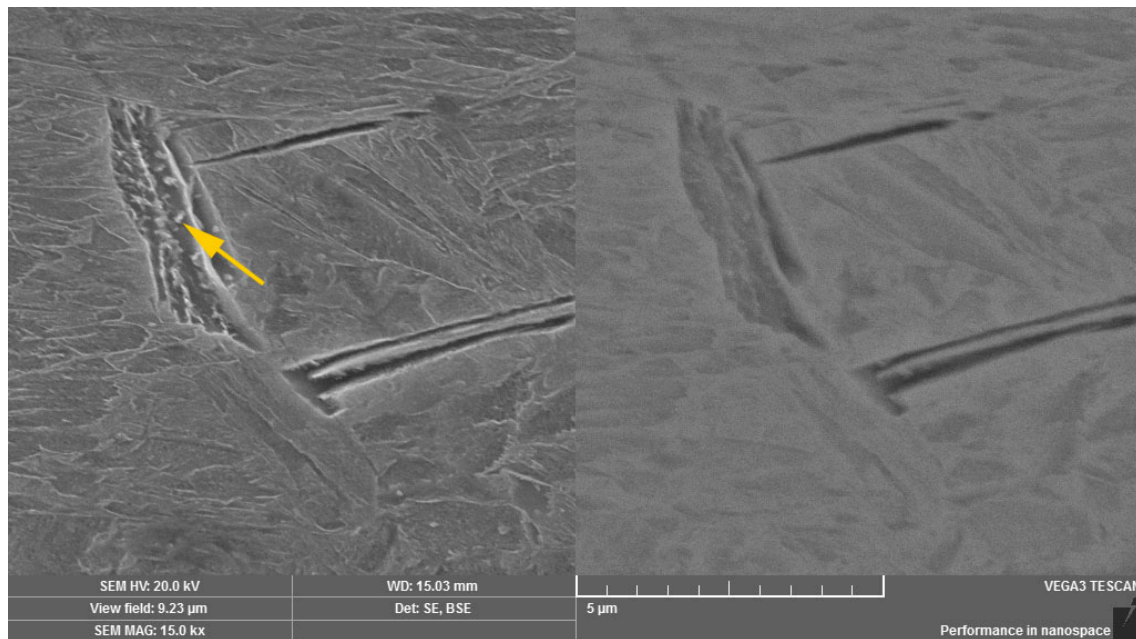
Using the method of scanning electron microscopy, the micromorphology of the tempered microstructure in the mode of secondary electrons and the material contrast of the analyzed areas in the mode of backscattered electrons were observed in more detailed way. The method of sequential etching, using the 2% Nital etchant, was selected for an accurate visualization and subsequent identification of the bainitic structure. By this mentioned procedure, it was possible to observe the presence of individual bainitic ferrite plates in which ϵ -carbide formations (indicated with arrows in Figure 7) were distributed. The more intense effect of the etchant led to more significant etching of the ferritic phase of the bainitic structure as well as more visible image of the ϵ -carbide formations. These microareas are visible in Figure 8. Thicker plates of bainitic ferrite can be observed quite close to the grain boundaries. The given microstructure characteristics correspond to the occurrence of lower bainite, i.e., martensitic structure tempered at a lower temperature. In the etched microstructure, the occurrence of several types of inclusions was also observed and according to the standard ČSN ISO 4967 (420471), the given inclusions exhibited a subcritical size but their distribution close to grain boundaries or directly at grain boundaries can represent the low-energy critical microcrack propagation. Using the method of energy-dispersive spectroscopy, the analysis of the chemical composition from the selected area confirmed that there is mainly the presence of MnS inclusions, especially in the central area of the microstructure (Figure 9). In relation to the microstructure, it was also possible to observe the Al-based oxides and Si-based oxides through the overall longitudinal section area. Moreover, the complex sulfoxides (Figure 10) were visible close to the grain boundaries. Grain boundaries are indicated with arrows.

Figure 7. Occurrence of ϵ -carbide in the plate of the bainitic ferrite. Dual representation of the analyzed area: **(left)** SE mode, **(right)** BSE mode.

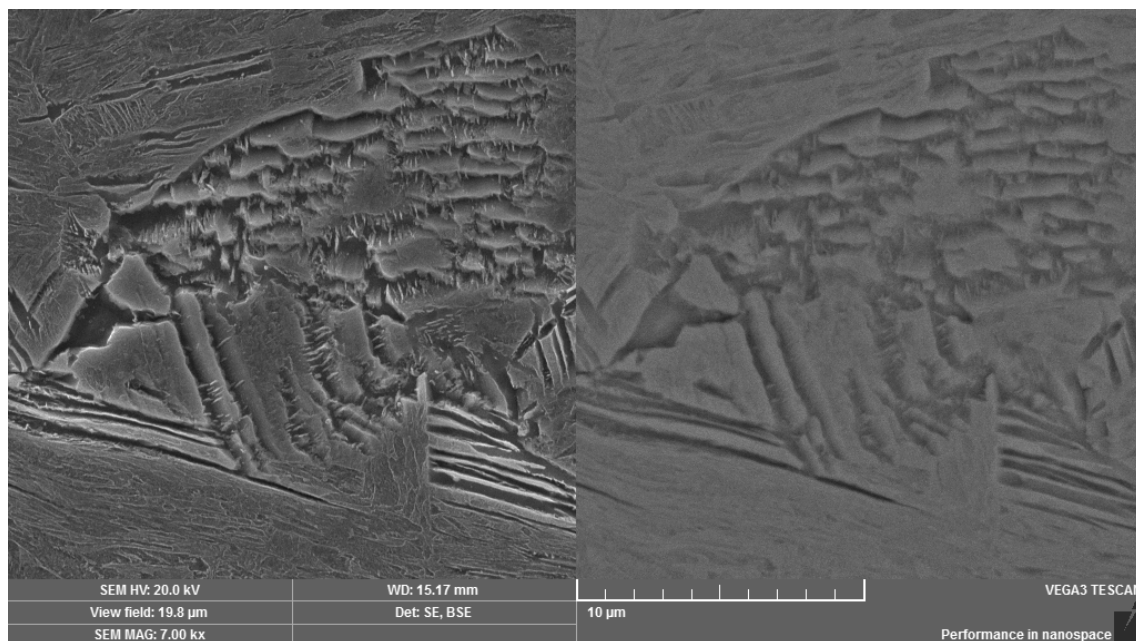
Figure 8. Occurrence of carbide formations in the structure of lower bainite. Dual representation of the analyzed area: **(left)** SE mode, **(right)** BSE mode.

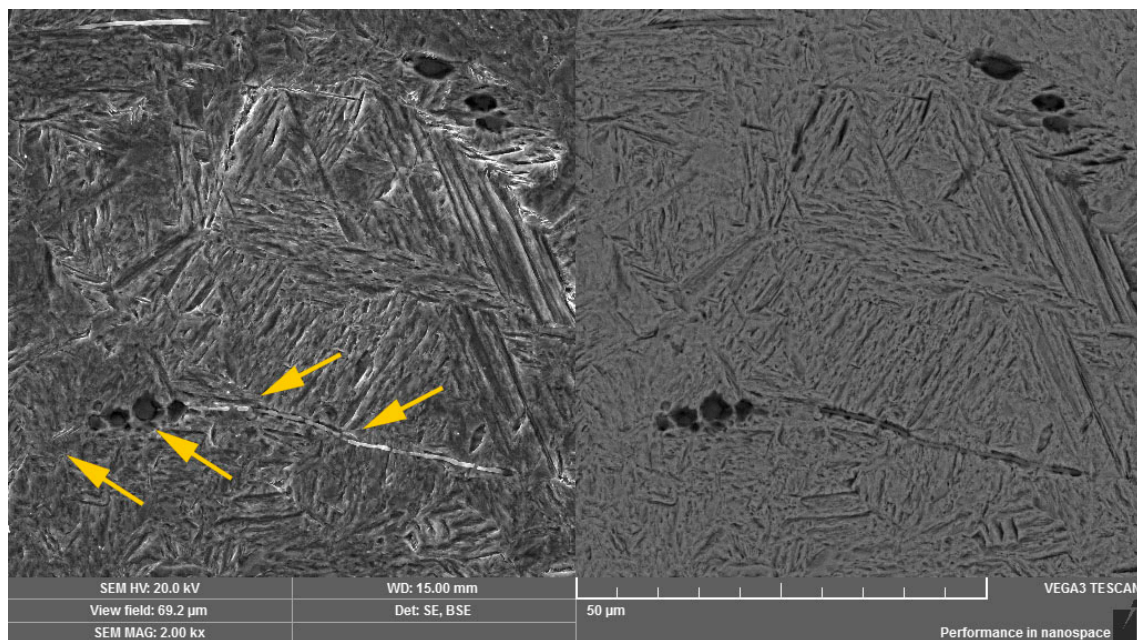
Figure 9. Oxide inclusions on the basis of Al, Si and MnS. Dual representation of the analyzed area: **(left)** SE mode, **(right)** BSE mode.

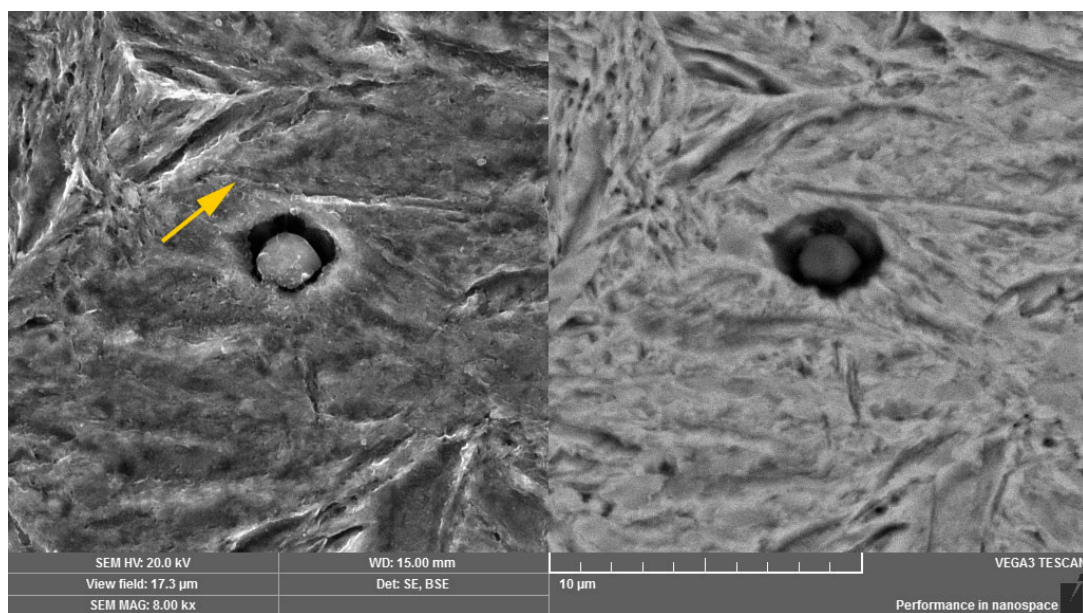
Figure 10. Complex sulfoxides close to the grain boundaries. Dual representation of the analyzed area: **(left)** SE mode, **(right)** BSE mode.

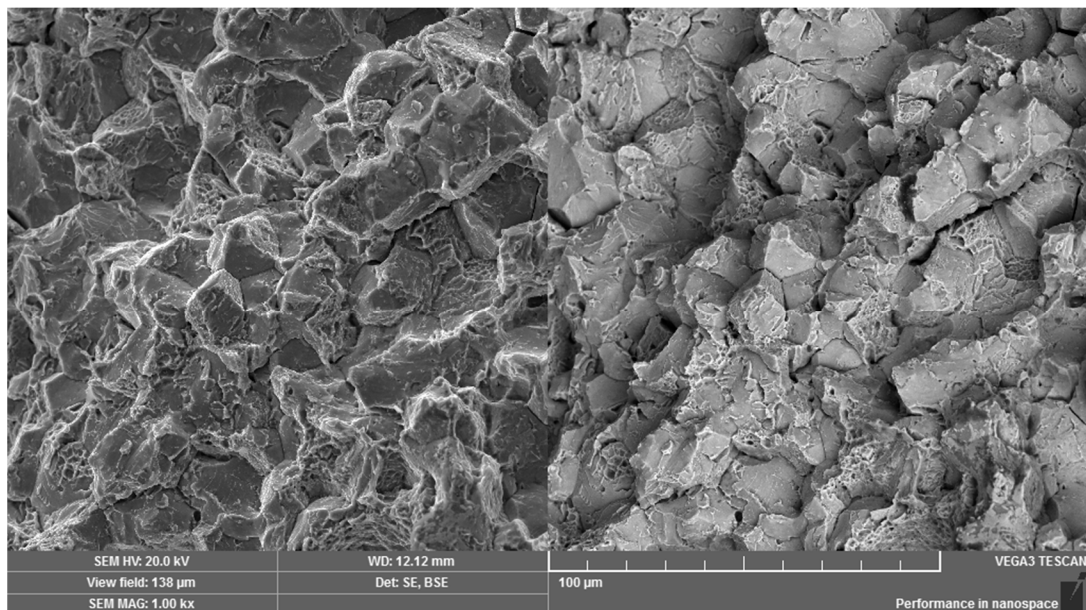
Scanning electron microscopy in secondary and backscattered electrons mode was used for the fractographic analysis of the fracture surface, relating to a broken screw from practice. Both the peripheral and the central regions were formed mainly by intercrystalline micromechanism with visible pit micromorphology which was observed at revealed grain boundaries (Figure 11). However, the observed pits were shallow with small geometric parameters. The fracture surface exhibited significant decohesion at the grain boundaries (Figure 12) and a large number of intercrystalline microcracks. The fracture surface characteristics correspond to the low-energy propagation of a critical microcrack. In the overall area of the fracture surface, there was no significant direction of the fracture surface due

to the shear loading. In addition, there was not any impressed area which could be the consequence of the movement and abrasion of the fracture surfaces.

Figure 11. Operational fracture of a high-strength screw under shear loading. Dual representation of the analyzed area: (left) SE mode, (right) BSE mode.

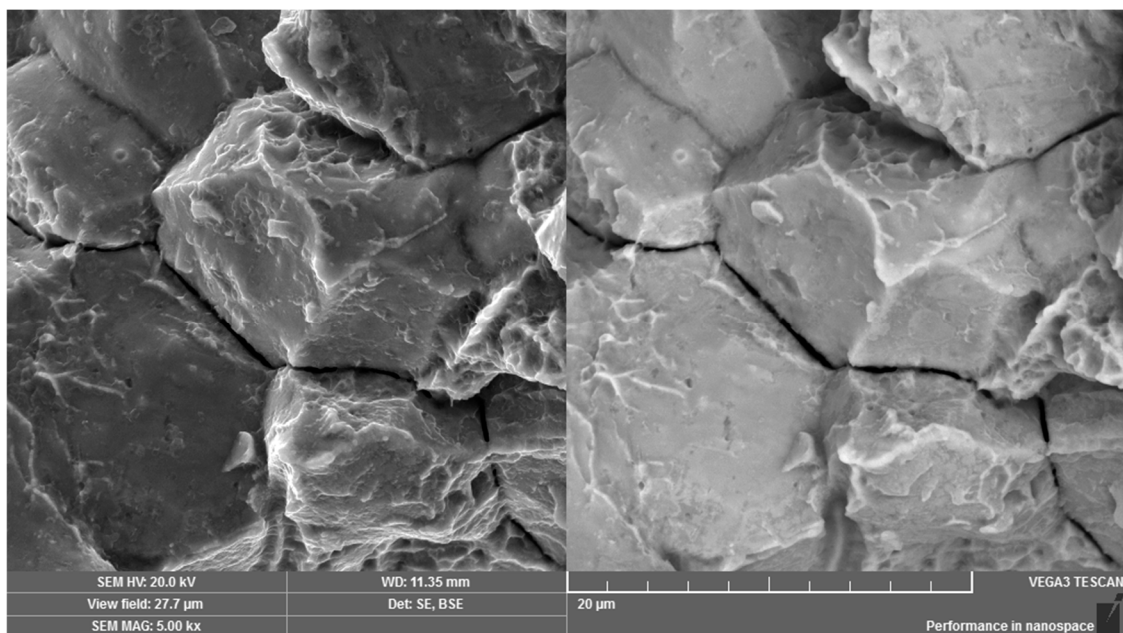
Figure 12. Visible weakness of grain boundaries. Dual representation of the analyzed area: (left) SE mode, (right) BSE mode.

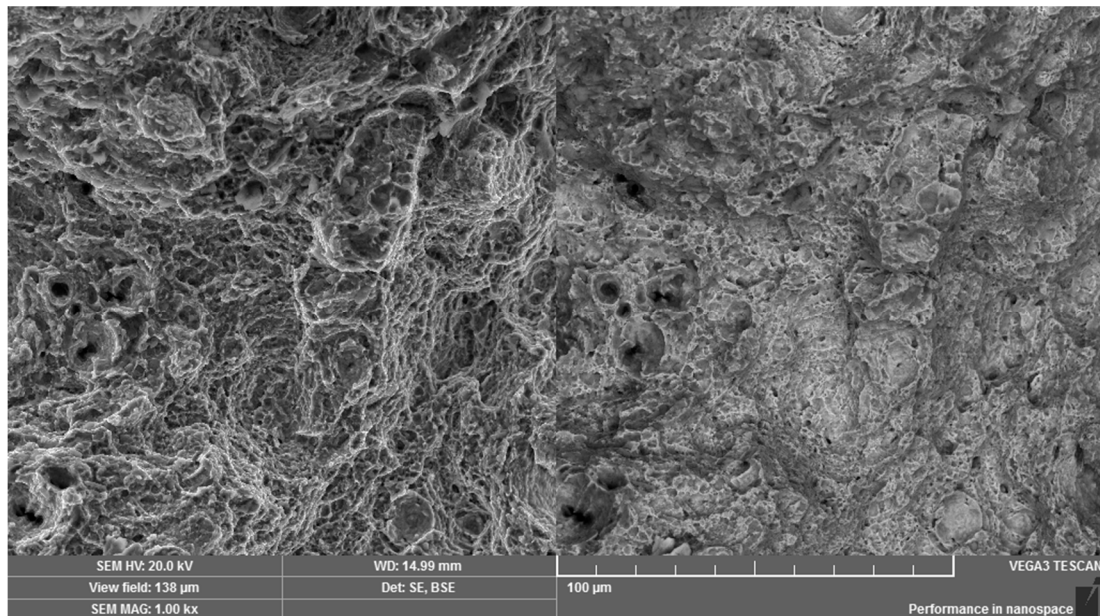
It is important to point out that the fracture surface of the broken screw did also not exhibit the required degree of toughness and, therefore, further steps of investigation were based on an experimental comparative method, relating to the comparison of the laboratory fracture of the broken screw from practice with the tensile fracture of the identical unbroken screw. The analysis of the fracture surfaces was supplemented by the measurement of the HV1 hardness. Using tensile loading, the fracture surface of the unbroken screw showed a high degree of toughness with the presence of deep pits of the ductile fracture resulting from overloading (Figure 13). The average hardness value from the three measurements

for this screw was 372 HV1. The hardness corresponds to the tempering heat treatment of the martensitic structure at a higher temperature and it stands for the microstructure of the upper bainite.

Figure 13. Fracture surface of the reference high-strength screw under tensile loading. Dual representation of the analyzed area: (left) SE mode, (right) BSE mode.

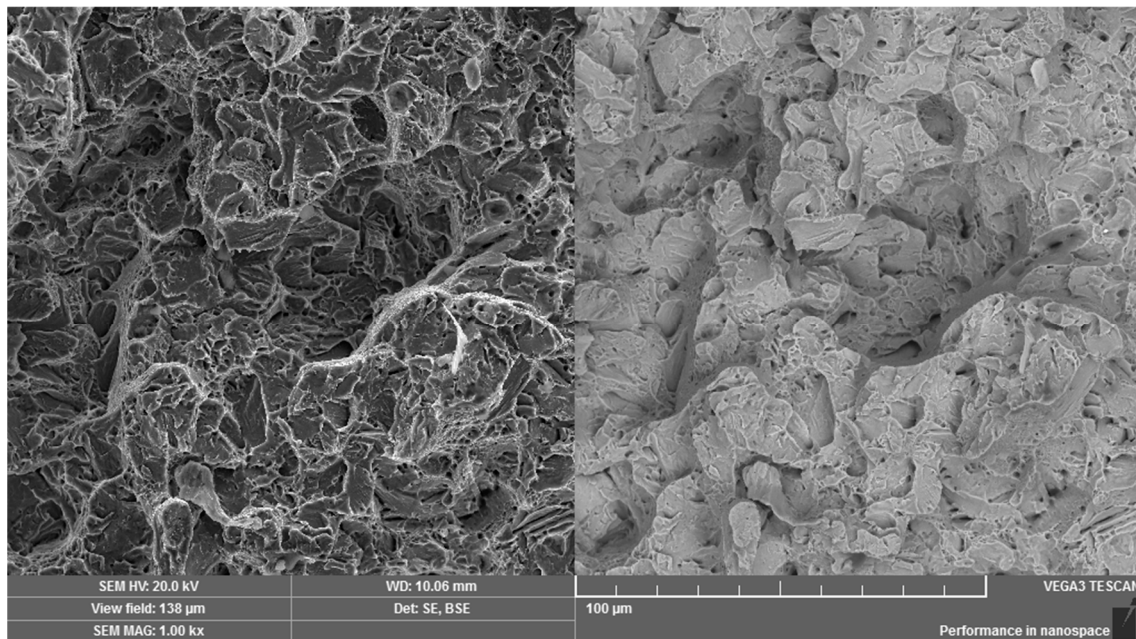
In order to obtain comprehensive information on the fracture properties of the broken screw for the whole volume of its threaded part, a fracture surface under tensile loading was prepared from the rest of the screw in the laboratory. The given fracture surface was mainly formed by a transcrystalline rupture micromechanism (Figure 14) with the visible pit micromorphology. The pits had greater depths and geometric parameters and, moreover, they were represented in greater numbers, which gives important information on high-energy rupture (Figure 15). After tensile loading, the fracture surface showed a higher degree of ductile fracture, but, for a given joining component, it is not an ideal or expected failure in relation to screw overloading and it corresponds to the microstructure of lower bainite with higher hardness values in comparison with the microstructure of the upper bainite. Based on the fractographic analysis and findings, further and additional measurements were performed in relation to HV 1 hardness, which was measured step by step from the edge to the core of the screw [28]. Each area was subjected to three hardness measurements from which the average value was calculated. An average value of 891 HV1 was obtained for the edge, an average value of 796 HV1 was gained for the area between the edge and the center and an average value of 695 HV1 was obtained for the central area of the screw. For evaluation, the Vickers hardness measurement method under HV1 loading used standard ČSN EN ISO 6507-1 Metallic materials—Vickers hardness test—Part 1: Test method. Hardness was measured on the device V10 K/AQ.

Figure 14. Laboratory fracture of the broken screw in operation after tensile loading. Dual representation of the analyzed area: (left) SE mode, (right) BSE mode.

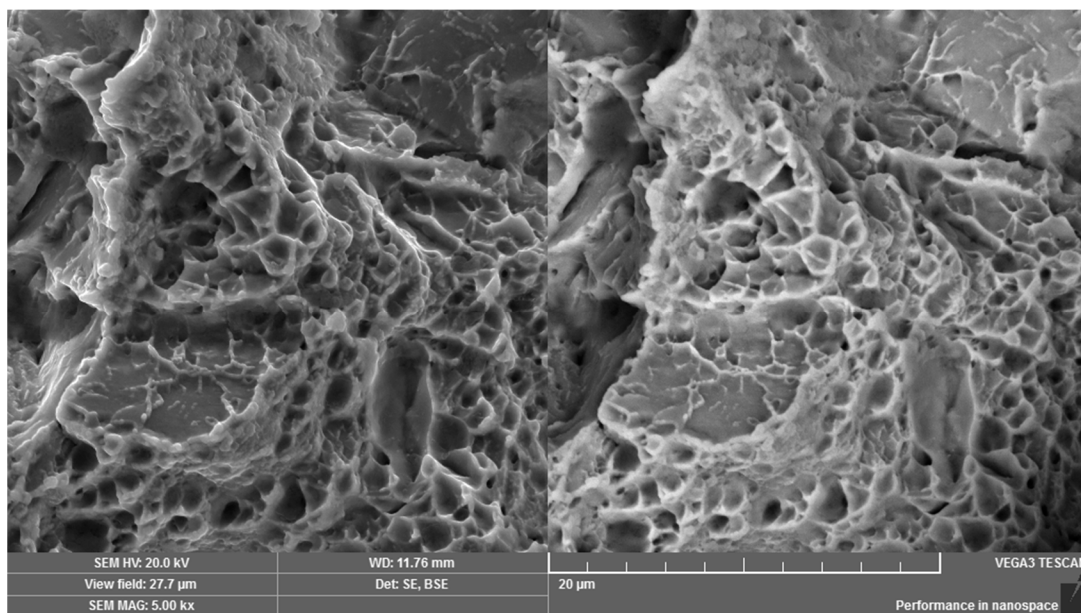
Figure 15. Detail of the pit micromorphology for the broken screw in operation after tensile loading. Dual representation of the analyzed area: (left) SE mode, (right) BSE mode.
