## Nanosize Carbides Formation and Fatigue Life Increase of Stainless Steel by Electron Beam Treatment

Electron – beam treatment with 20 J/cm<sup>2</sup> energy density of Fe-0.20C-23Cr-18Ni stainless steel increases fatigue life up to 2.1 times. Fracture surface investigations have been carried out by the methods of scanning and transmission diffraction electron microscopy and layer-by-layer analysis of structural phase states and defect substructure of steel subjected to the multicyclic fatigue tests, has been made as well. Nanosize (Cr,Fe)<sub>23</sub>C<sub>6</sub> carbides formation and physical reasons of steel fatigue life increase by electron – beam treatment have been found out.

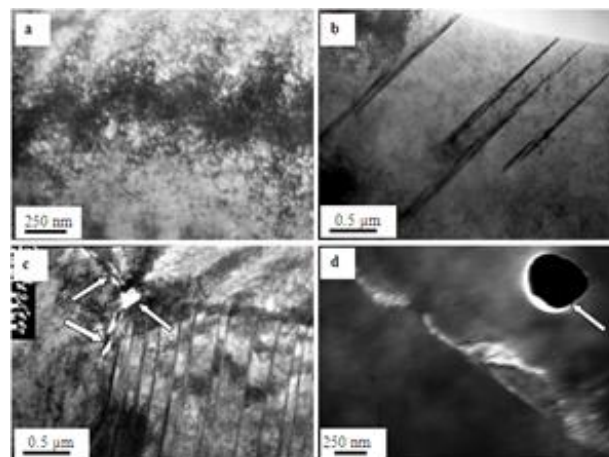
**Fig. 1** – Electron microscope image of Fe-0.20C-23Cr-18Ni steel structure in the initial state; a-c – light fields; d – dark field obtained in the (111) $\gamma$ -Fe reflection. Second phase particles, located along the boundary (c) and in the grain volume (d), are shown by the arrows in (c) and (d)

In the initial polycrystal state of the investigated steel there's a dislocation substructure like networks (Fig. 1, a) with  $\sim 4 \cdot 10^{10}$  cm<sup>-2</sup> scalar density in the grain volume. The other element of a grain structure is microtwins (Fig. 1, b) of the one twinning system, rarely-of two systems.

the form of longitudinal interlayers with the longitudinal sizes of 0.2 – 1.0  $\mu$ m and transversal sizes 40–100 nm are revealed along the grain boundaries (Fig. 1, c). They have the round form 0.5  $\mu$ m (Fig. 1, d) in the grains volume.

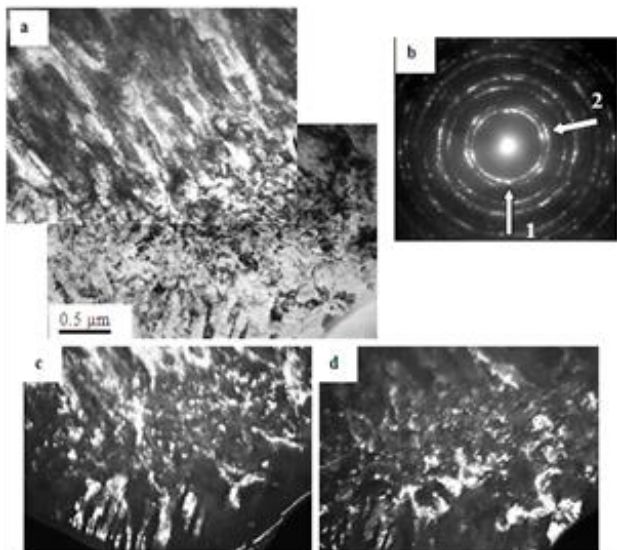
**Fig. 2** – Nanocrystal structure, forming in the surface layer the fractured steel; a – light field; b – microelectron diffraction pattern, reflections, where dark zone 1 –(c), 2 – (d) is obtained, are shown by the arrows; c, d – dark fields, obtained in  $(111)\gamma\text{-Fe}$ ,  $(111)\gamma\text{-Fe}+(002)\gamma\text{-Fe}$  diffraction rings reflections

tion of two microtwins systems leads to steel volume formation with nanoscale structure (Fig. 2). Crystallite sizes vary from 25 to 80 nm.

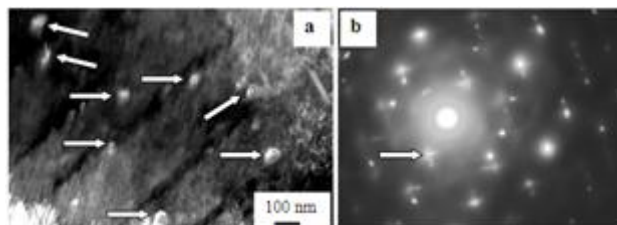
**Fig. 3** – Electron-microscope image of carbide-phase particles, detected in the grain volume of steel surface layer, treated by electron beam and followed fracture; a – dark field, obtained in  $(002)\gamma\text{-Fe} + (006)\text{Cr}_{23}\text{C}_6$  coincidence reflections; b – microelectron diffraction pattern, the reflection is shown by the arrow where the dark field has been obtained; carbide-phase particles are shown by the arrows in (a)

Samples fatigue loading, subjected to the preliminary electron-beam treatment, is followed by the formation of the second phase precipitates (Fig. 3, a). The particles have got round form; the particle sizes vary from 20 to 40 nm. Micro-electron diffraction pattern indexing, obtained from the material volume, containing the second phase precipitates (Fig. 3, b) allows to say that given particles are carbides on the basis of  $(\text{Cr}, \text{Fe})_{23}\text{C}_6$  chromium composition.
